Mary Kathleen Uranium Mine – Blasting and Slope Stability Initiatives

By
Kent Bannister, ARMIT, FAusIMM (CP), CEO Kent Bannister Pty Ltd, (KBPL)

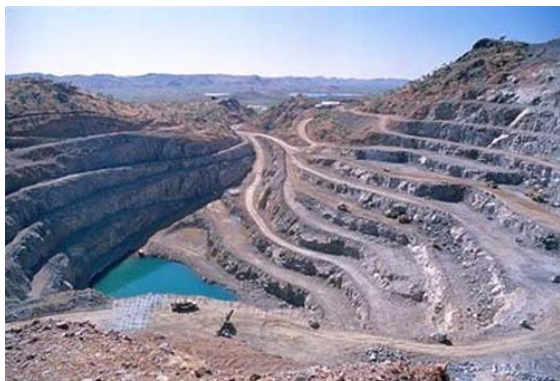
Figure 1 Mary Kathleen Open Cut – 1978

Multi row waste blasts were undertaken at every opportunity to improve fragmentation. (Foreground in Figure 1.)

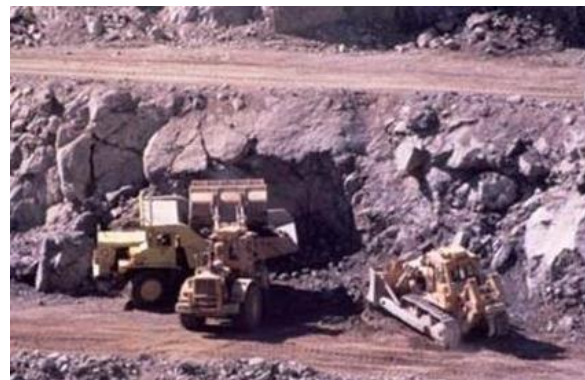
Figure 2 North- South Production Bench showing multiple open joint sets

The joints dipping at approximately 45° were particularly problematic resulting in production bench crest failures. This in turn resulted in excessive burdens on blast holes, poor fragmentation, secondary breaking, toe drilling, and poor distribution of grade control data. At considerable costs bulldozers were engaged to assist front end loaders maintain production bench RL. Bulldozer track grouser plates were replaced every month due to the highly abrasive rock. Joint orientation also resulted in wedge failures along final safety catch benches. On occasion final safety catch benches were too narrow for equipment to complete clean-up operations. The removal of loose material from safety catch benches was an important procedure for the semi-circular 300m high east wall as rain events during the summer wet season caused any loose material on benches to wash over bench crests and cascade to the bottom of the pit. During wet weather mining operations would be stopped and workers removed from the open cut.

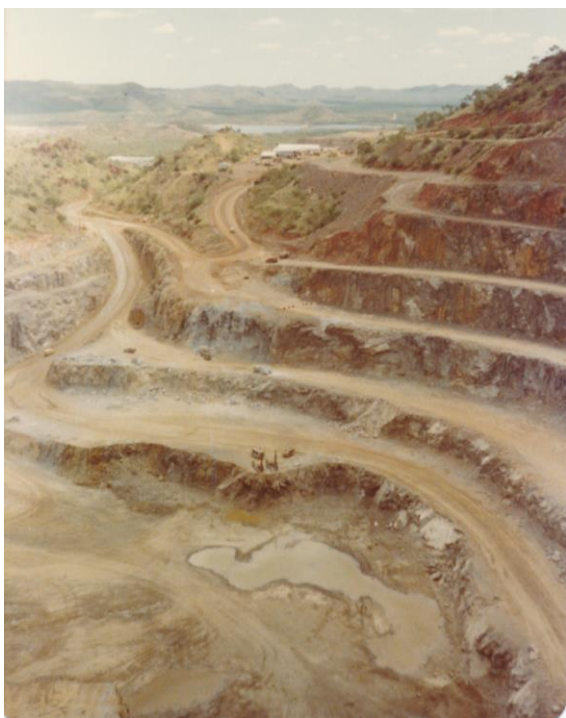
*Figure 3 Looking North,
Joint sets resulting in production bench
crest and wedge failures - 1980*

Stable production bench crests were important for safety and to facilitate grade control and selective blasting. It was observed the south dipping joints were slightly more stable than West dipping joints so by maximising the number of faces orientated in the East-West direction

reduced the number of bench crest failures. Figure 3 shows drill rigs working on an East-West oriented production face. Crest failures can be seen on the North-South faces.

To prevent crest and bench wedge failures Golder Associates proposed the use of cable dowels to prevent the movement of the open joints. The dowel design required a relatively stiff fully grouted cable. The concept was to stop the joints lifting apart during blasting, thus maintaining friction along the joint plains. Figure 3 shows a major wedge failure in progress on the 1032 RL bench with bench access being restricted above and below the wedge failed.

The designs were completed by and the first installations supervised by Golder Associates. The dowels were installed in the crest of the 1016 RL bench in the area of the problematic wedge. Trim blasting practices were also changed as discussed below. The result was successful with retention of the wedge. On the back of this success it was decided to dowel the crest of the next major catch bench on the 1000mRL. Two rows of crest dowels at 1.5m centres on a staggered pattern for all final crests was planned. The rows of dowels being 15m long 1m below and 12m long 2m below the crest line. The initial design was for the dowels to be drilled at 45°, being at right angles to the joint orientation however, this proved impractical due to the frequent collapse of drill hole collars. Holes drilled at 60° were more stable so this was adopted as the design standard.

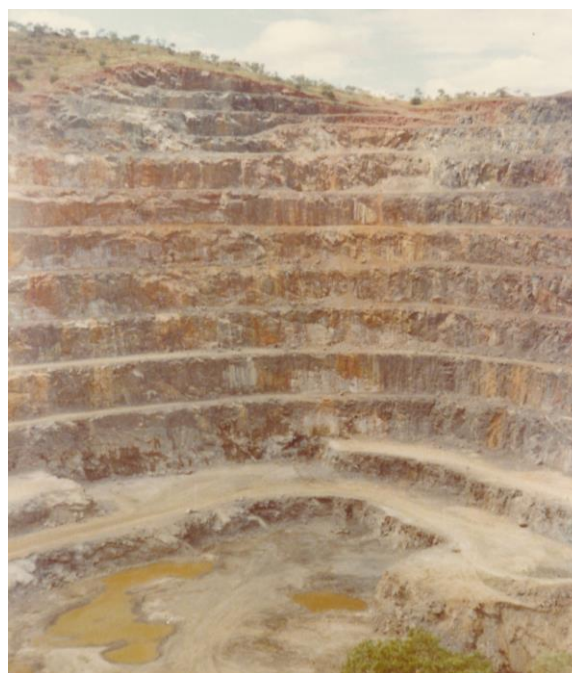
*Figure 2 Looking south east – Centre of
picture is the first 24m high final batter in
Queensland. - 1980*

The blasting and dowelling initiatives significantly improved the condition of the final batters. At the time the Queensland Mining Regulations limited batters to a maximum height of 20m. Approval to increase the final batter height from 16m to 24m was sort and granted. The base of the 16m high trim blast was first dowelled with 6m long dowels then the final 8m was Presplit. Drill hole spacing and charges were developed over time with results comparable to Post Splits as can be seen in Figure 5. Holes were initiated with detonating cord and delayed with 5 millisecond surface delays.

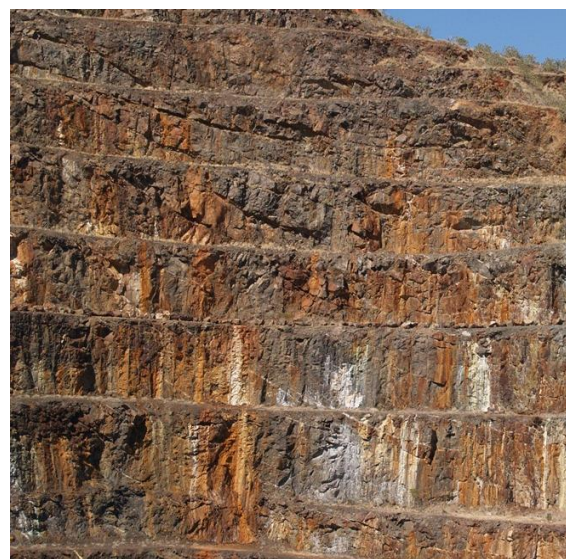
Figure 5 shows half barrel hole traces on the batters and the reduced wall damage below the 1000mRL bench.

Figure 5 Looking South East final batter showing Rock Fence on the 1000mRL bench and 24m face - 2012

To improve loose rock retention on the major catch bench rock fences were install on the crest of the bench. The fence consisted of boulders over 1m in diameter placed in a single row along the crest of the bench. To prevent the boulders from falling a hole was drilled into each boulder and then the bench. A short length of cable was grouted in the boulder and the bench.
